Technical Service Bulletin

SUBJECT: Telma does not function above 50mph (80km/h)

Products Affected: Telma installation on Chevrolet C5500 chassis

Effective Date: September 2008

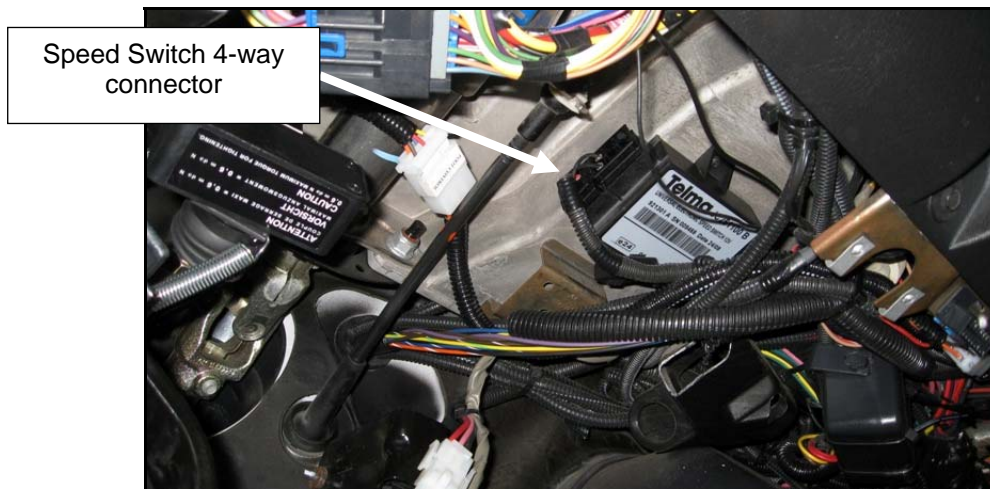
Figure 1

The OEM speed signal available on C5500 may be either 4,000 pulses per mile (ppm) or 120,000 ppm. The Telma speed switch may not function above 50mph (80km/h) if the speed signal is 120,000 ppm.

If the Telma does not work above 50mph (80km/h) you may have a chassis built with the 120,000 ppm signal.

Move the tan speed signal wire (Figure 1) from position 3 to position 1 of the 4-way plug (Figure 2) of the speed switch so that the speed switch will function with both 4000 ppm and 120,000 ppm speed signals.
