## Technical Service Bulletin

**SUBJECT:** New AD Connecting Block Position

**Products Affected:** AD50-90(BB201XXX), AD72-00(BE201XXX)

**Effective Date:** July - 2009

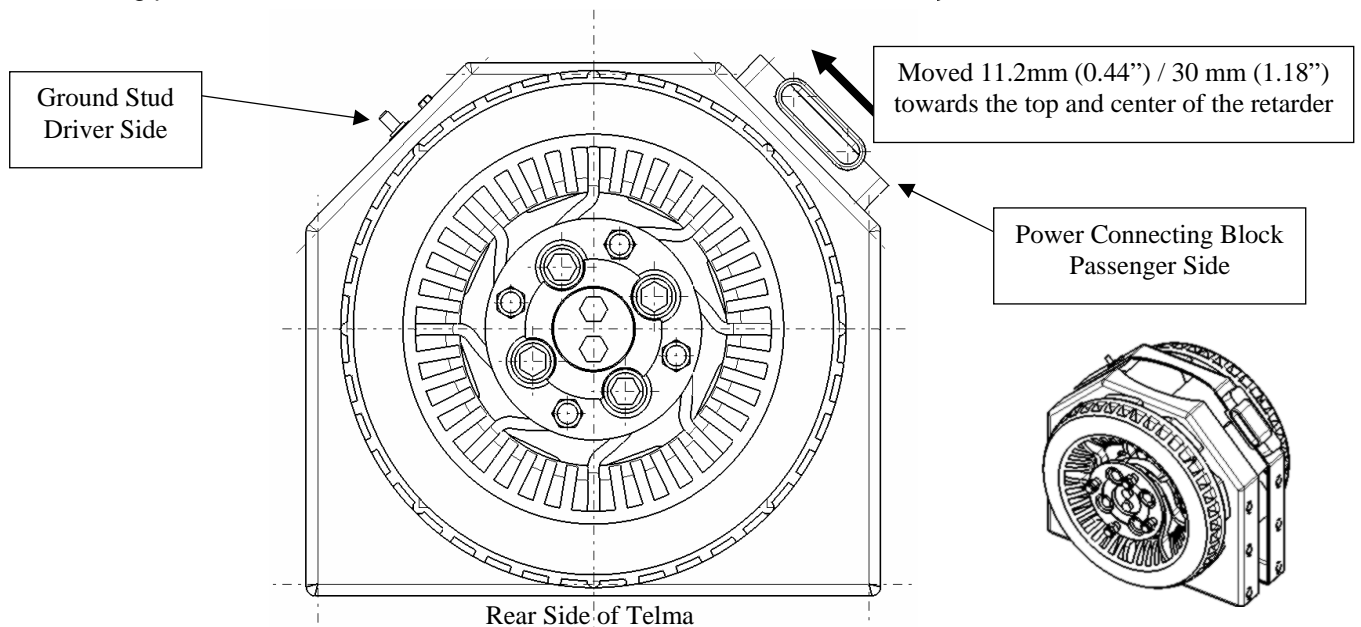
We are pleased to announce the modification of the AD connecting block location. The new location moves the connecting block away from the Telma side plate toward the top and center of the retarder.

The AD50-90 will have the connecting block moved 11.2mm (0.44 inches) towards the top and center of the retarder and the AD72-00 will have the connecting block moved 30mm (1.18 inches) towards the top and center of the retarder.

The two AD models affected will have connecting blocks that extend past the top of the Telma. The AD50-90 connecting block will extend 13.4mm (0.53 inches) above the top of the retarder, and 6mm (0.24 inches) above the top of the retarder for the AD72-00. This dimension will be taken into consideration by Telma engineering when issuing installation drawings so no special considerations will need to be taken by the installer or end user.

When ordering your Telma retarder use part number BB301158 to replace BB201158, use part number BE301152 to replace BE201152, and use BE301157 to replace BE201157.

All kits using previous part numbers will automatically be adjusted with no change in kit number.
